West Virginia Chemical Leak
Etowah, Kanawha County, West Virginia
TDD No TL01-14-01-001

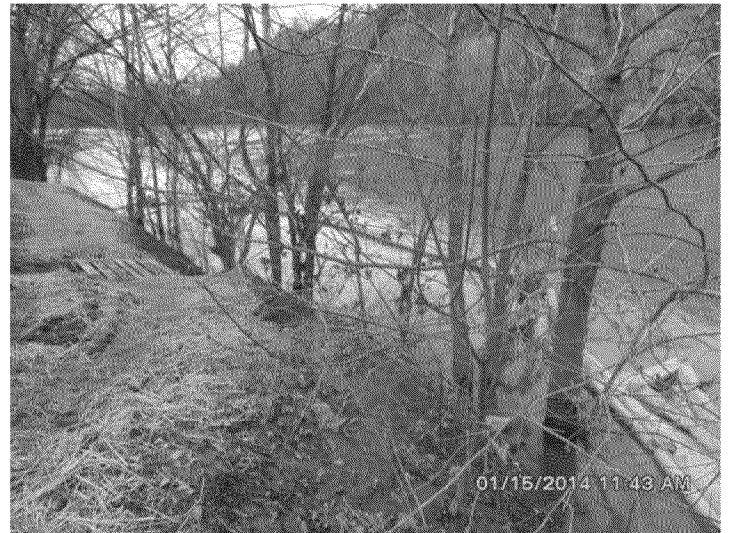
Photo No. SAM_1741; Taken on 01/15/14 at 12:27 hours by START MG. Booming on the south end of the site

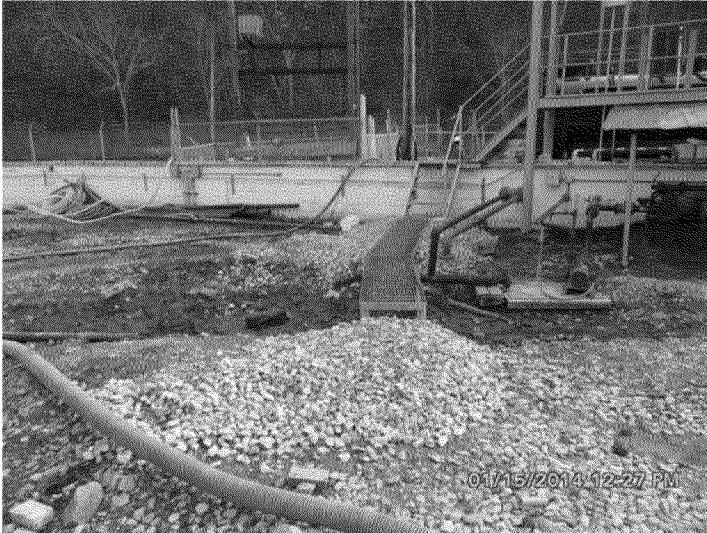
Photo No. SAM_1742; Taken on 01/15/14 at 12:30 hours by START MG . Gravel spread under walk way as per OSHA instructions

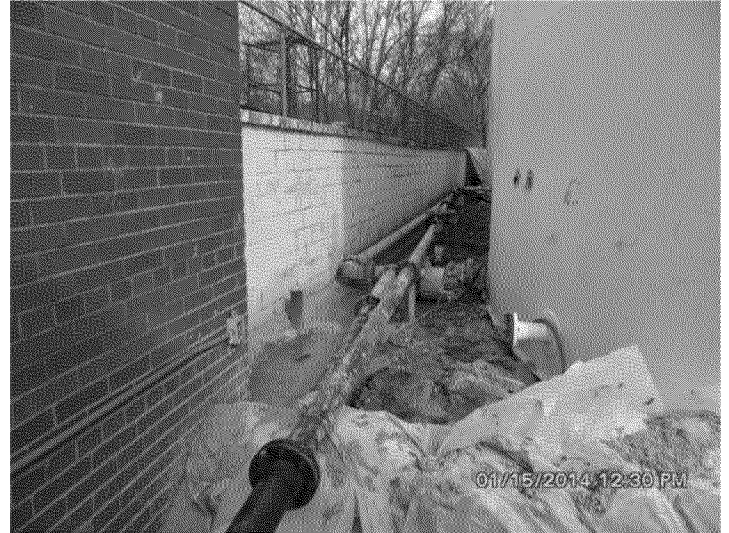
Photo No. SAM_1743; Taken on 01/15/14 at 12:51 hours by START MG. Water being pumped from behind containment wall

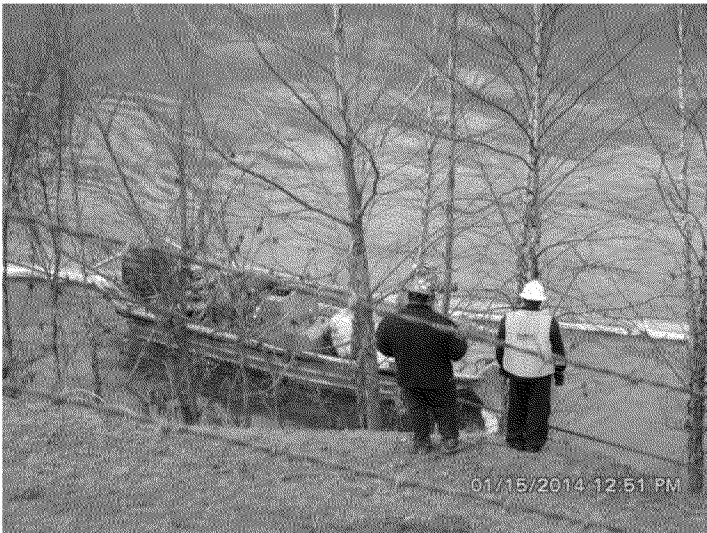
Photo No. SAM_1744; Taken on 01/15/14 at 12:56 hours by START MG . RP contractors installing cross booming

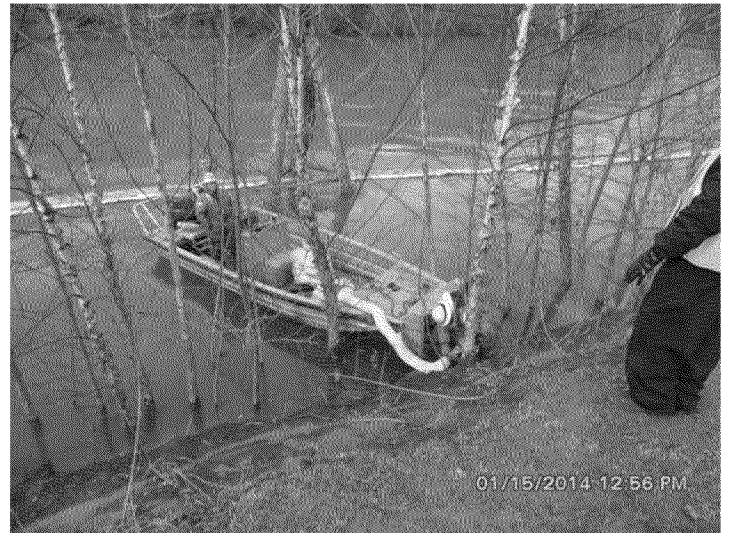
Photo No. SAM_1745; Taken on 01/15/14 at 13:02 hours by START MG. RP contractors anchoring cross booming

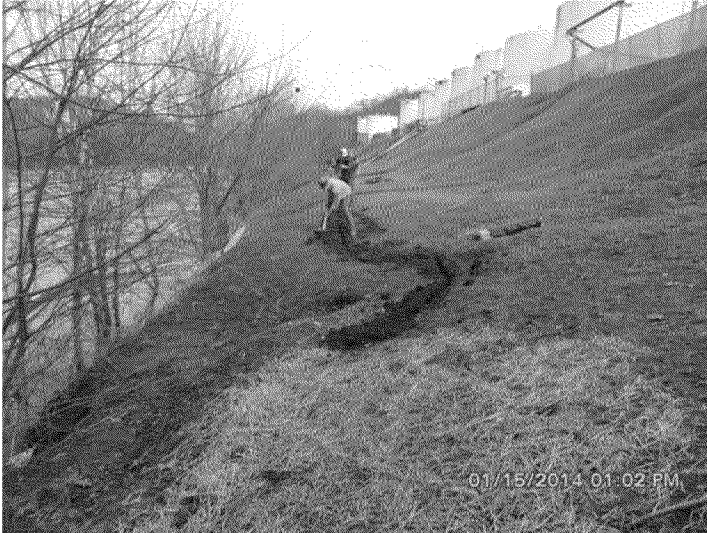
Photo No. SAM_1746; Taken on 01/15/14 at 14:24 hours by
START MG. RP contractors installing silt fencing

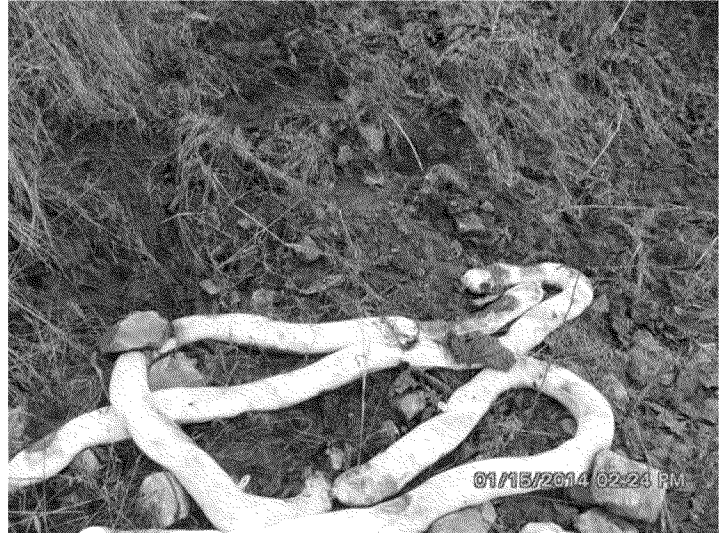
Photo No. SAM_1747; Taken on 01/15/14 at 14:24 hours by
START MG. Boom placed at bottom of slope where product was
found

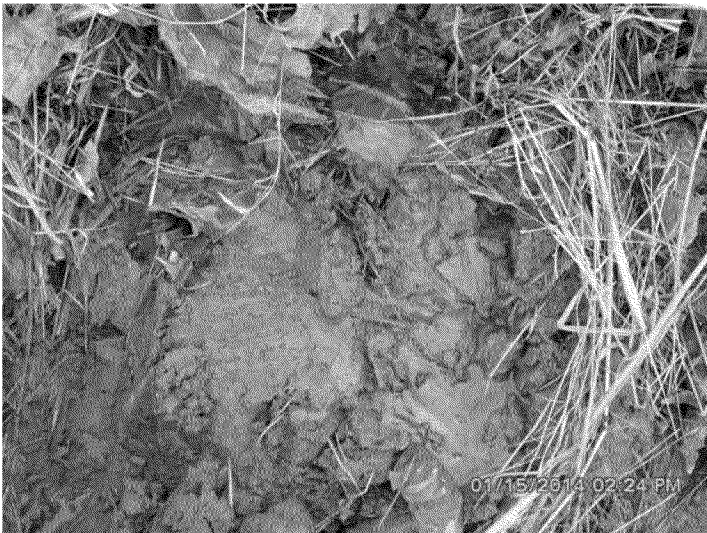
Photo No. SAM_1748; Taken on 01/15/14 at 14:53 hours by
START MG. Surface runoff at North end of the site

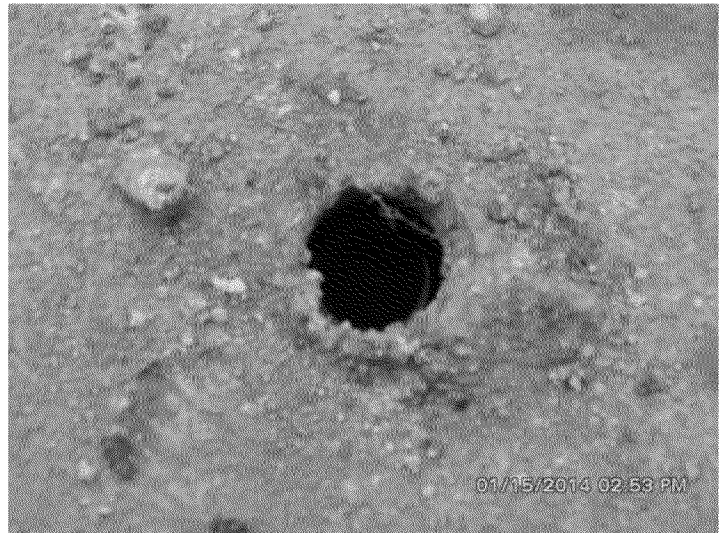
Photo No. SAM_1749; Taken on 01/15/14 at 15:05 hours by
START MG. Bore hole in the containment pad

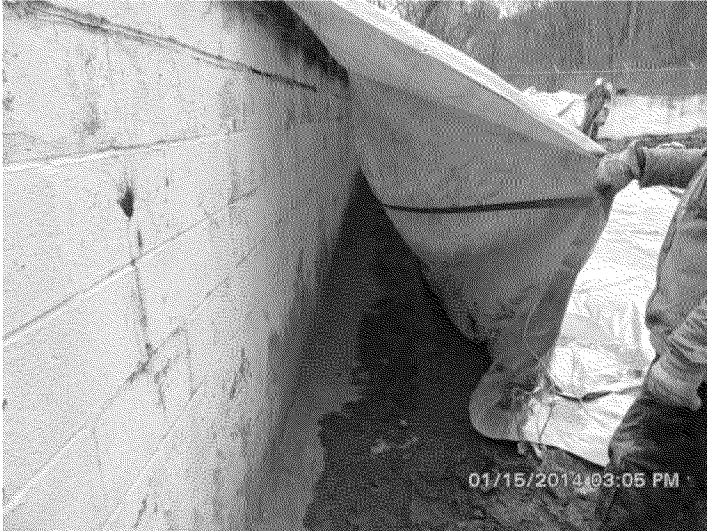
Photo No. SAM_1750; Taken on 01/15/14 at 15:05 hours by START MG. Cement placed along the inside of the containment wall

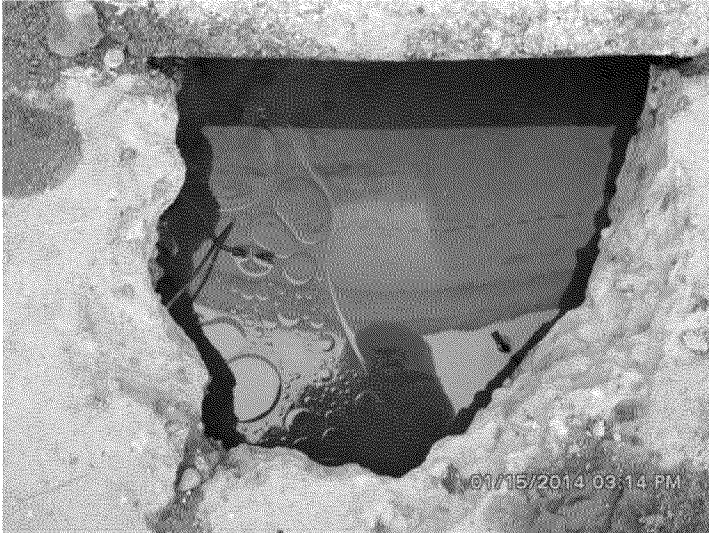
Photo No. SAM_1754; Taken on 01/15/14 at 15:14 hours by START MG. Product still surfacing in exploratory under edge of the tank

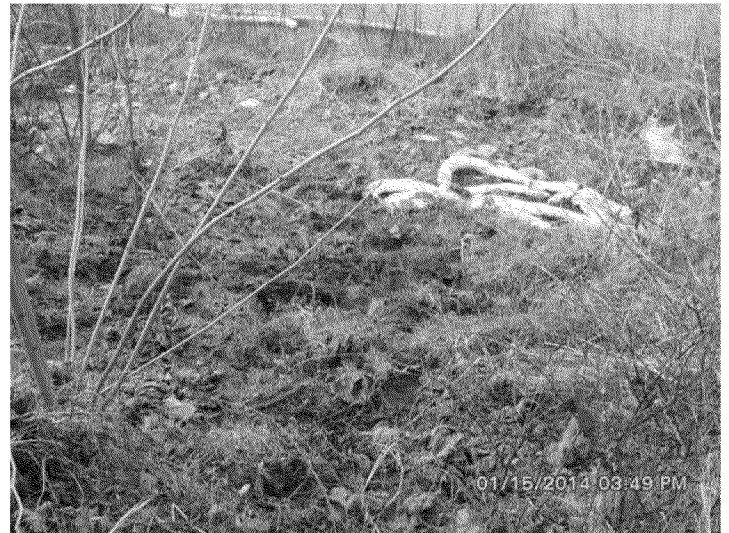
Photo No. SAM_1761; Taken on 01/15/14 at 16:02 hours by
START MG. Area where surface run off is traveling down hill
on the gas line entering the site

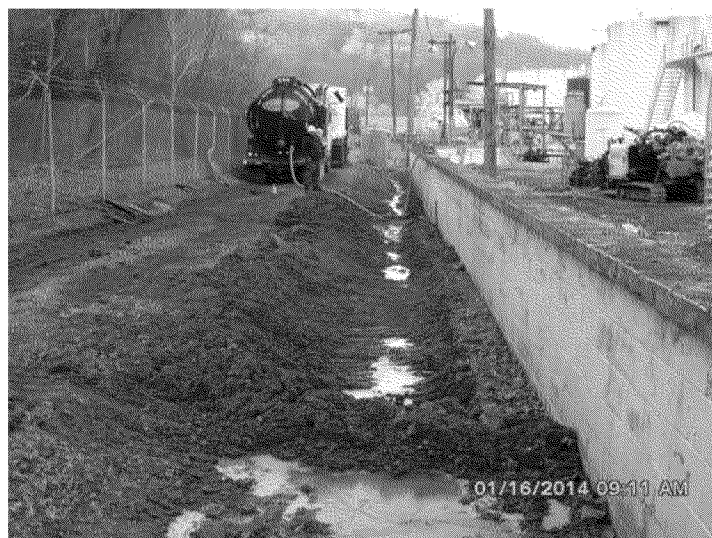
Photo No. SAM_1783; Taken on 01/16/14 at 10:34 hours by
START MG. standing water along outside of the containment
wall has been removed

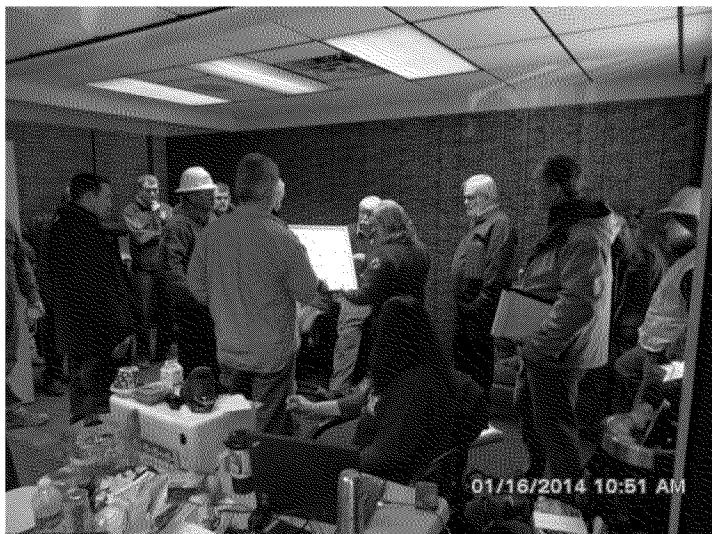
Photo No. SAM_1788; Taken on 01/16/14 at 11:41 hours by
START MG. Morning meeting

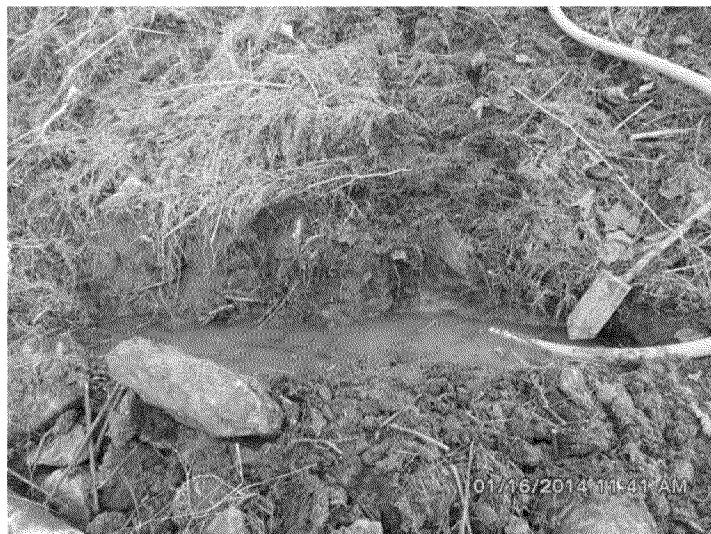
Photo No. SAM_1789; Taken on 01/16/14 at 12:51 hours by
START MG. Sump installed to collect surface runoff

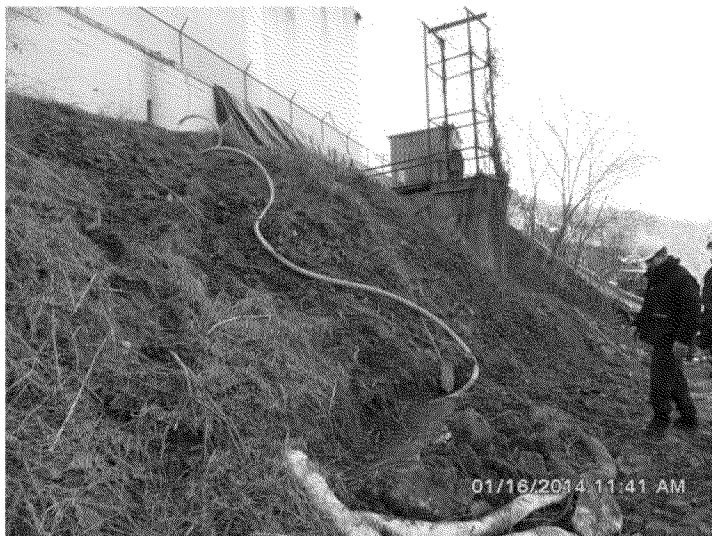
Photo No. SAM_1790; Taken on 01/16/14 at 12:57 hours by
START MG. Sump installed to collect surface runoff

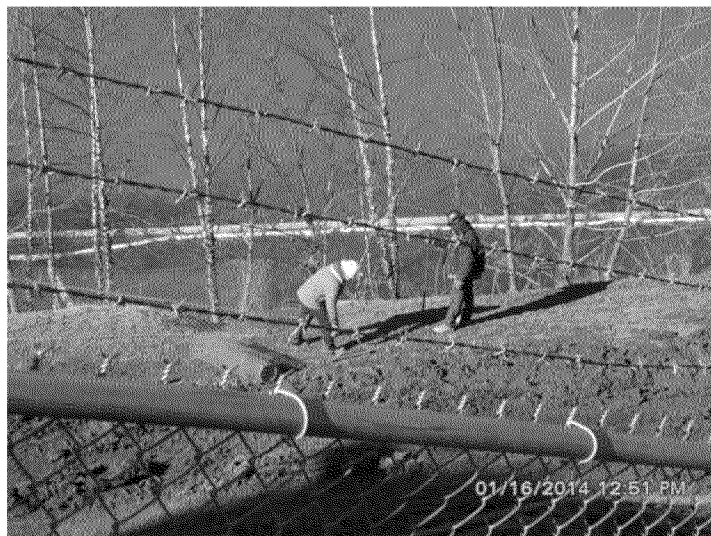
Photo No. SAM_1791; Taken on 01/16/14 at 12:57 hours by
START MG. Safety fence installation

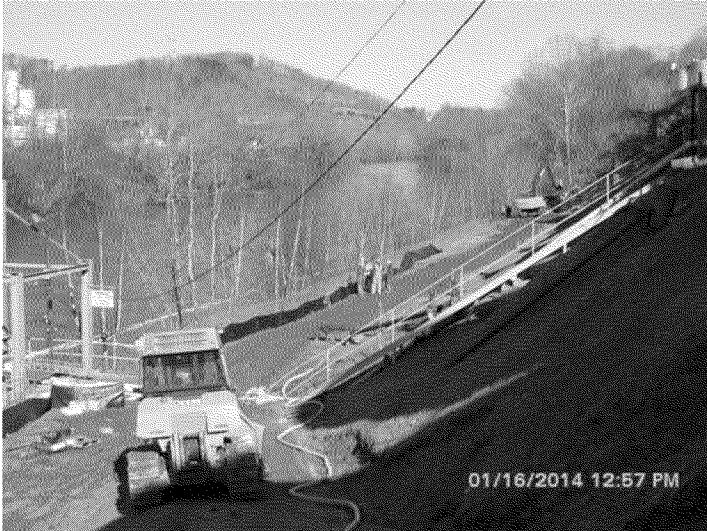
Photo No. SAM_1792; Taken on 01/16/14 at 13:45 hours by
START MG. Silt Fence installation

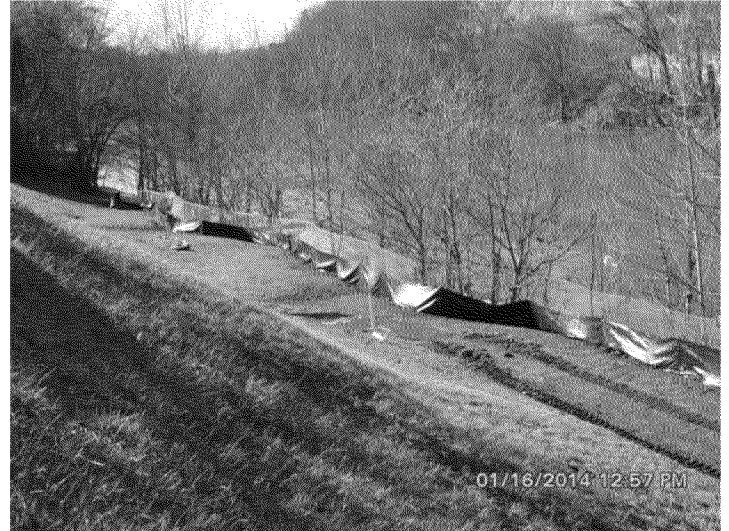
Photo No. SAM_1793; Taken on 01/16/14 at 13:49 hours by
START MG. Completed safety and silt fencing on south end of
the site

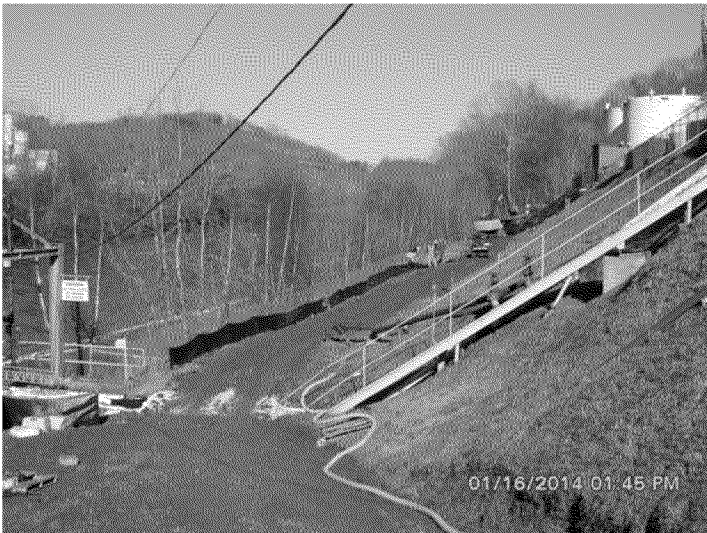
Photo No. SAM_1794; Taken on 01/16/14 at 13:49 hours by
START MG. Safety and silt fence installation on the north end of
the site

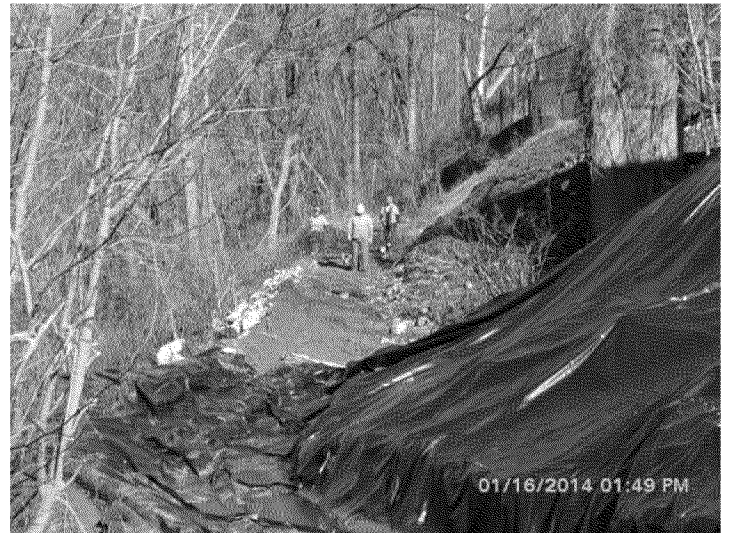
Photo No. SAM_1795; Taken on 01/16/14 at 13:49 hours by
START MG. Woody vegetation removal continues

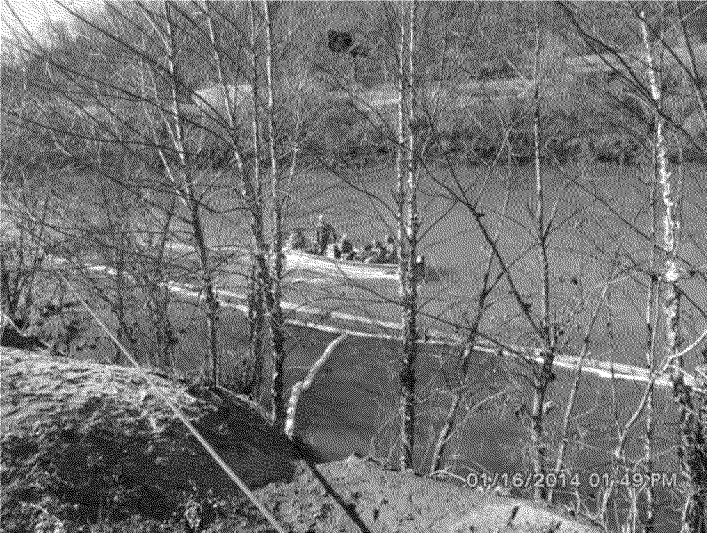
Photo No. SAM_1796; Taken on 01/16/14 at 13:50 hours by
START MG. Maintenance of the booming

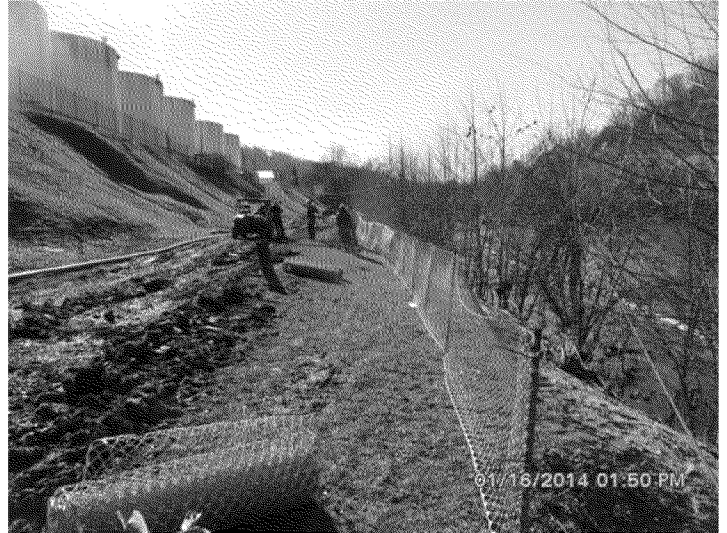
Photo No. SAM_1797; Taken on 01/16/14 at 14:09 hours by
START MG. Safety fence location in relation to the riverbank

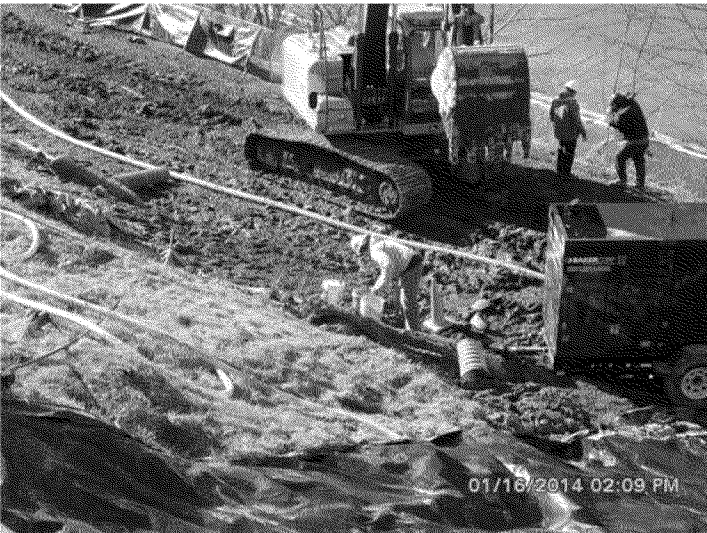
Photo No. SAM_1798; Taken on 01/16/14 at 14:09 hours by
START MG. Sampling of north monitoring well

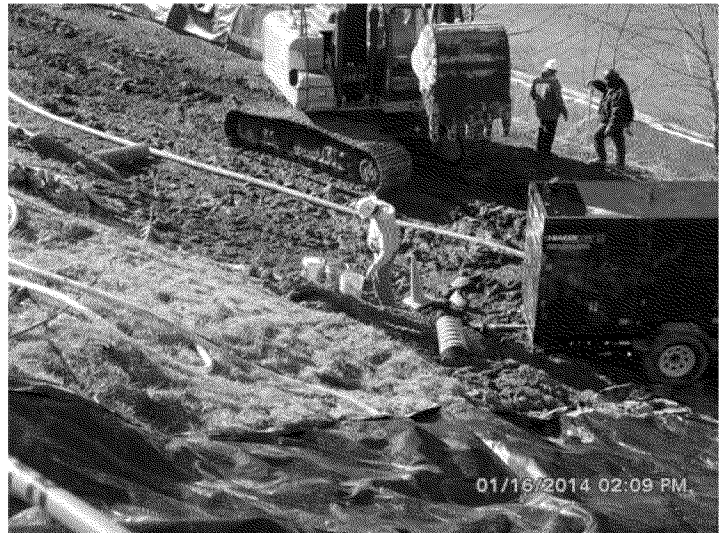
Photo No. SAM_1799; Taken on 01/16/14 at 14:09 hours by
START MG. Sampling of north monitoring well

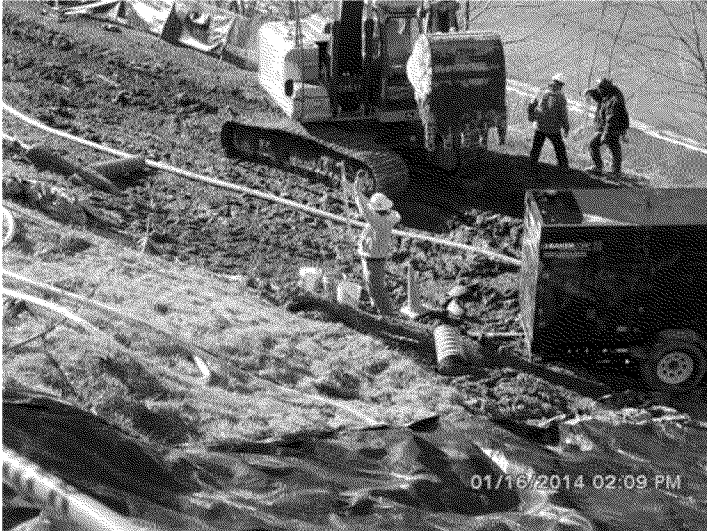
Photo No. SAM_1800; Taken on 01/16/14 at 14:12 hours by
START MG. Sampling of north monitoring well

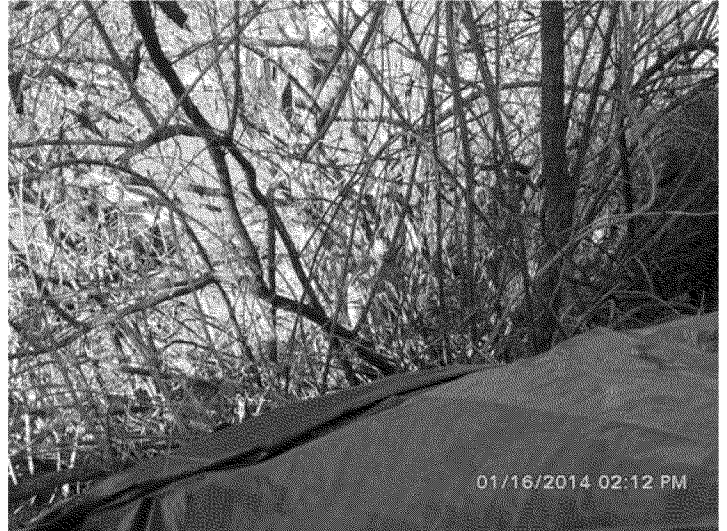
Photo No. SAM_1801; Taken on 01/16/14 at 14:13 hours by
START MG. Subcontractors removing woody vegetation

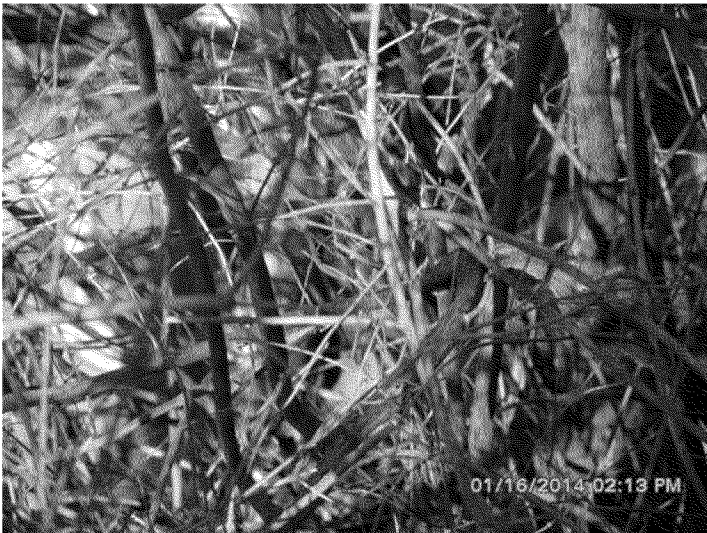
Photo No. SAM_1802; Taken on 01/16/14 at 14:13 hours by
START MG. Subcontractors removing woody vegetation

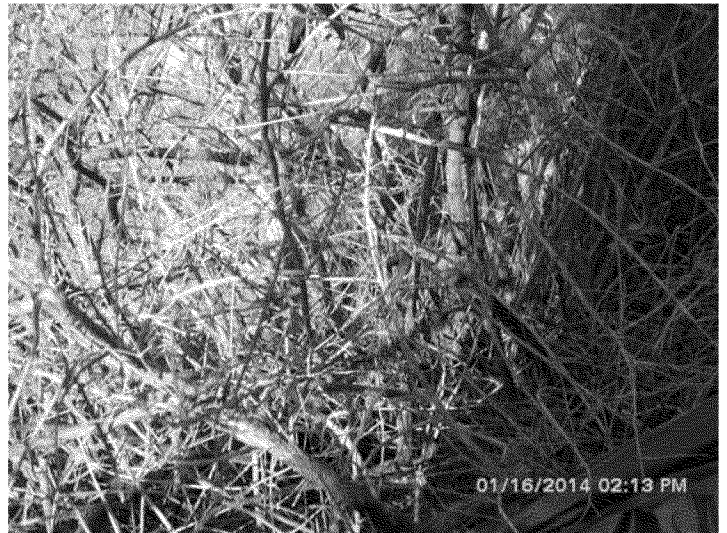
Photo No. SAM_1803; Taken on 01/16/14 at 14:13 hours by
START MG. Subcontractors removing woody vegetation

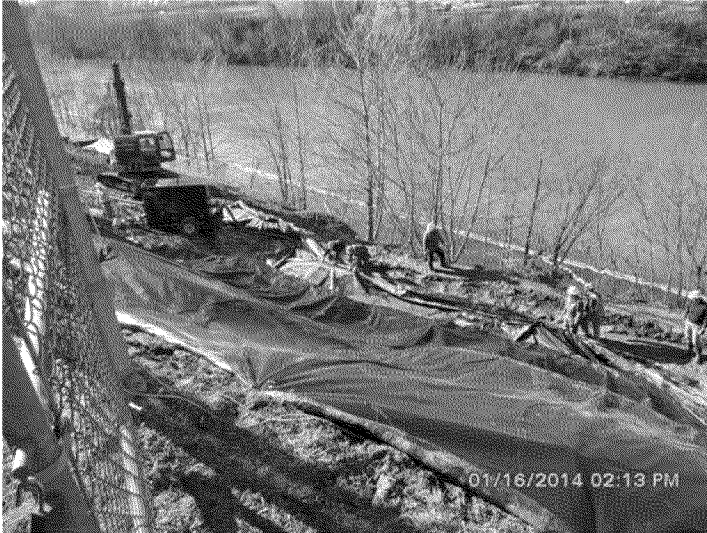
Photo No. SAM_1804; Taken on 01/16/14 at 14:15 hours by START MG. RP contractors rolling up liner to expand collection trench

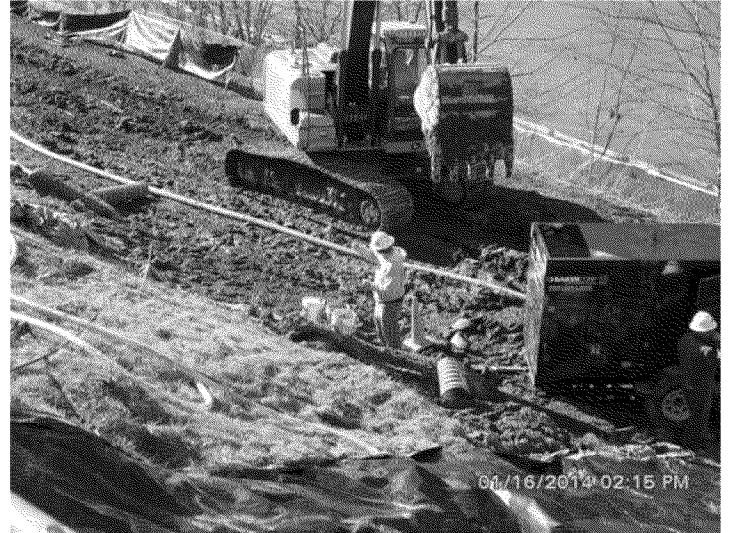
Photo No. SAM_1805; Taken on 01/16/14 at 14:16 hours by START MG. Sampling of north monitoring well

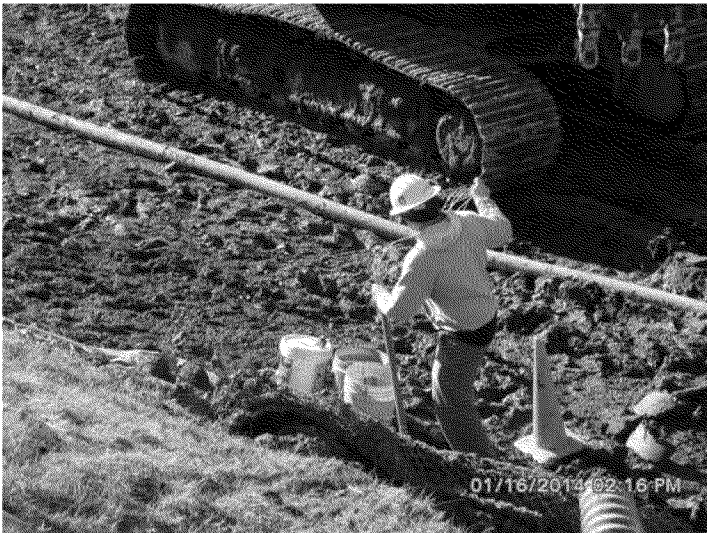
Photo No. SAM_1806; Taken on 01/16/14 at 14:17 hours by START MG. Sampling of north monitoring well

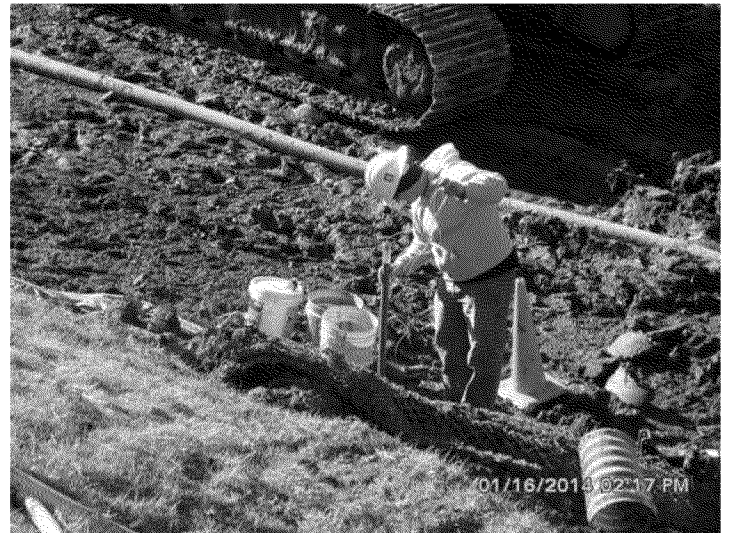
Photo No. SAM_1807; Taken on 01/16/14 at 14:24 hours by START MG. Sampling of north monitoring well

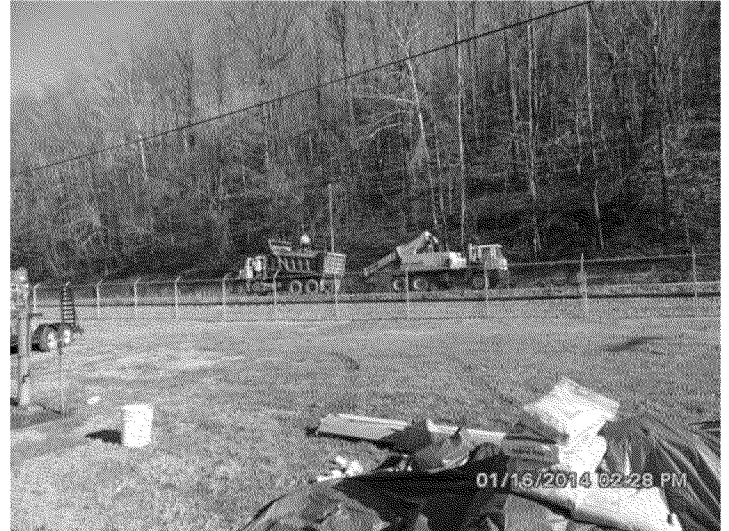
Photo No. SAM_1809; Taken on 01/16/14 at 14:54 hours by START MG . WV DOH working to divert run off water from the site

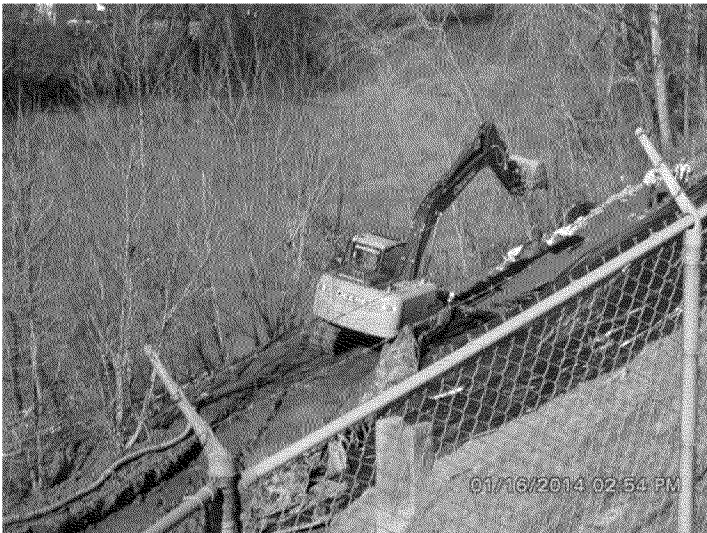
Photo No. SAM_1810; Taken on 01/16/14 at 15:01 hours by START MG. moving equipment in for expansion of the collection trench

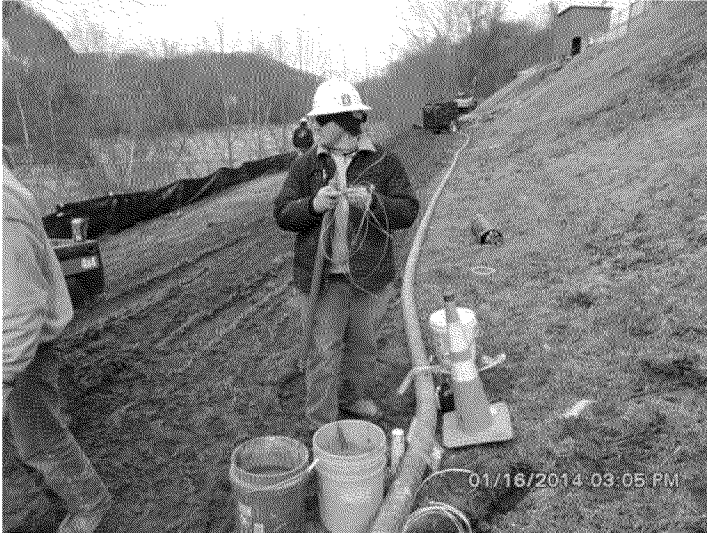
Photo No. SAM_1812; Taken on 01/16/14 at 15:08 hours by
START MG. Sampling of the middle monitoring well

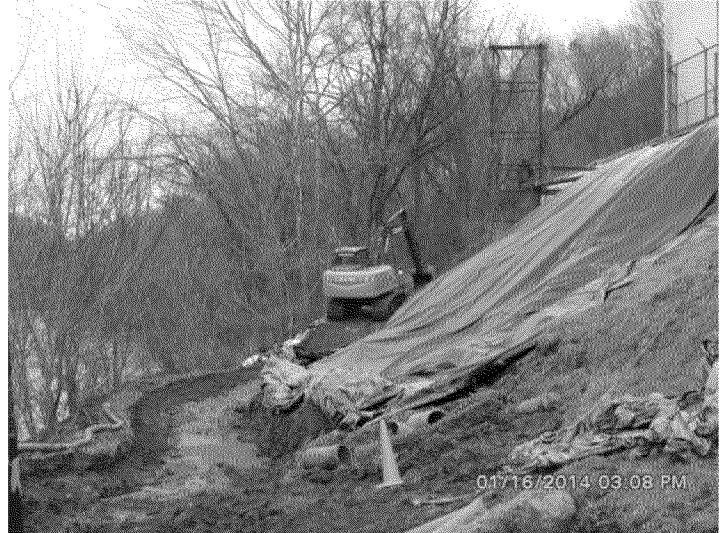
Photo No. SAM_1813; Taken on 01/16/14 at 15:15 hours by
START MG. Expansion of the collection trench

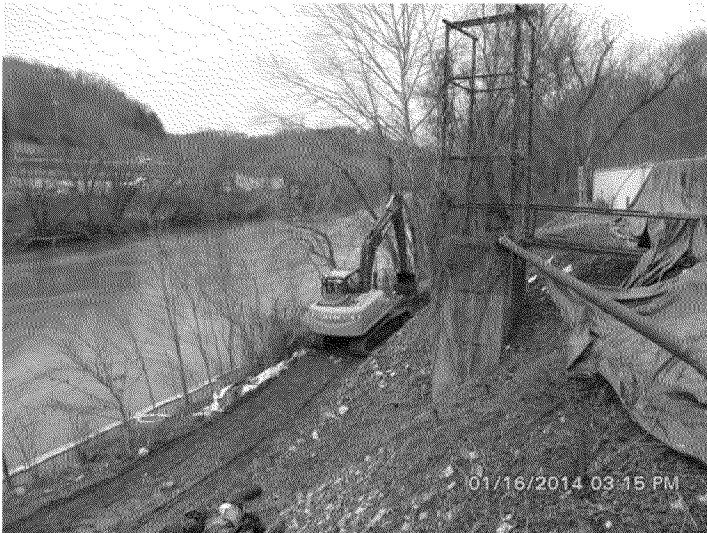
Photo No. SAM_1814; Taken on 01/16/14 at 15:16 hours by
START MG. Expansion of the collection trench

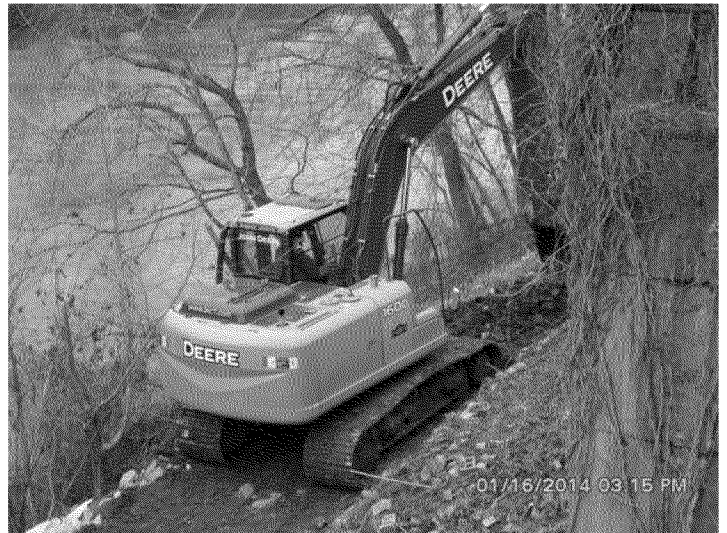
Photo No. SAM_1815; Taken on 01/16/14 at 15:18 hours by
START MG. Expansion of the collection trench

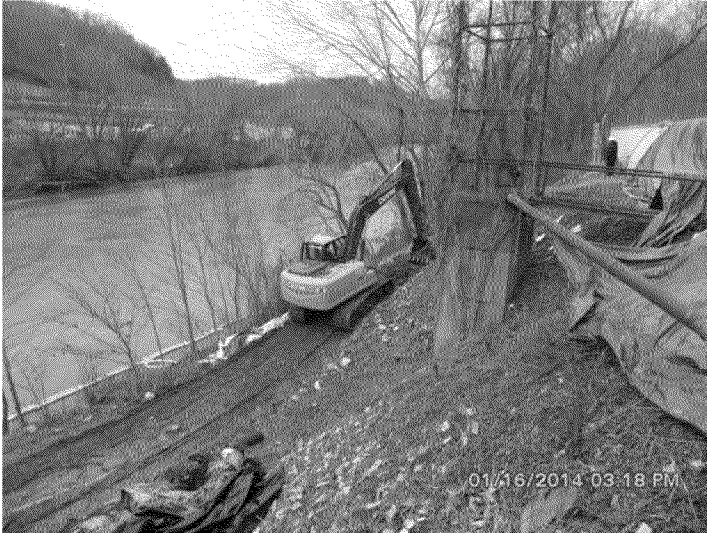
Photo No. SAM_1816; Taken on 01/16/14 at 15:28 hours by
START MG. Expansion of the collection trench

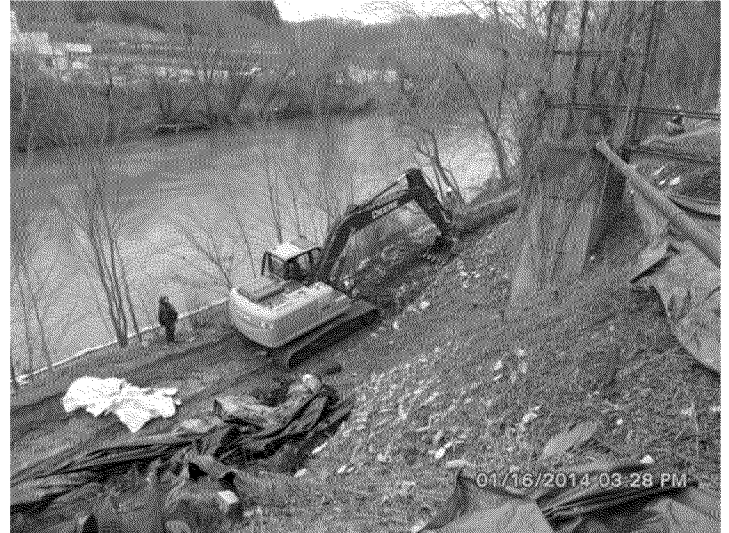
Photo No. SAM_1817; Taken on 01/16/14 at 15:30 hours by
START MG. Expansion of the collection trench

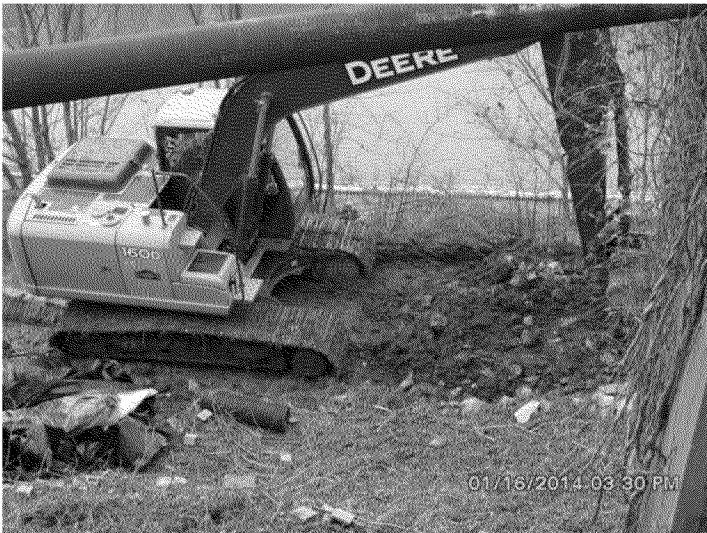
Photo No. SAM_1818; Taken on 01/16/14 at 15:32 hours by
START MG. Expansion of the collection trench

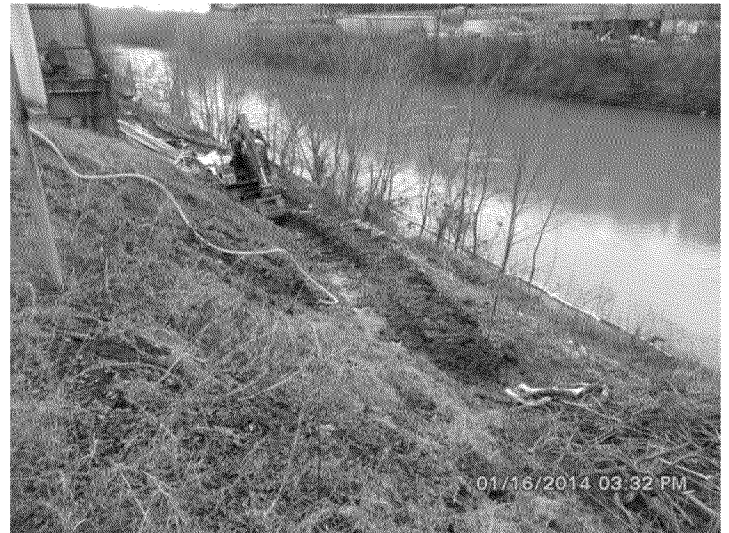
Photo No. SAM_1819; Taken on 01/16/14 at 17:07 hours by
START MG . Collection trench improvements

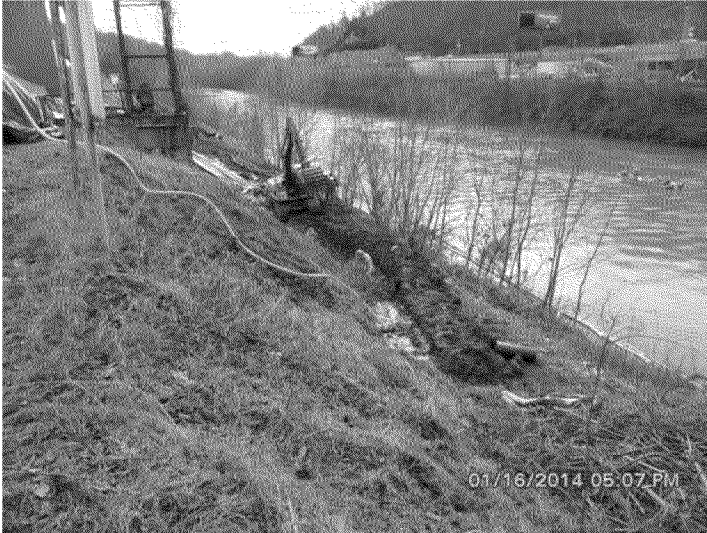
Photo No. SAM_1820; Taken on 01/16/14 at 17:15 hours by
START MG. Collection trench improvements

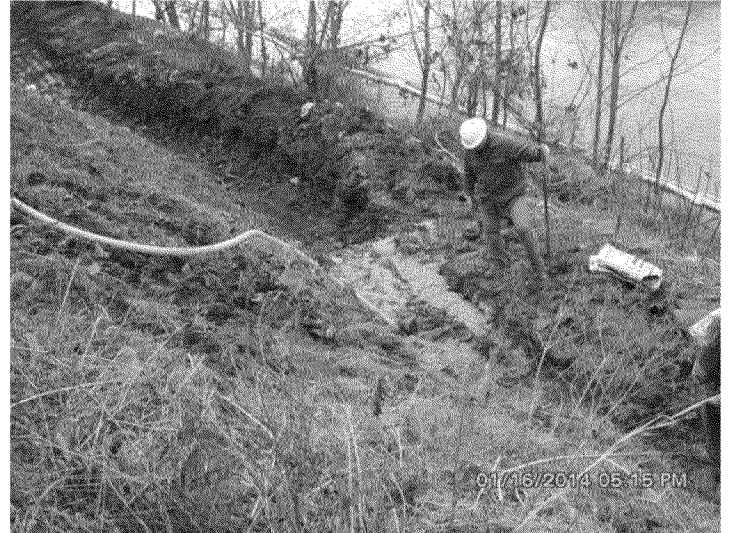
Photo No. SAM_1821; Taken on 01/16/14 at 17:16 hours by
START MG. Lining of the collection trench

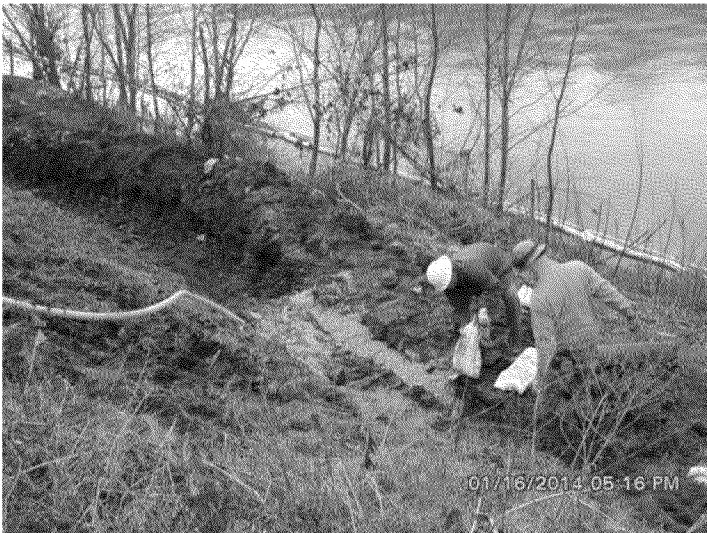
Photo No. SAM_1822; Taken on 01/16/14 at 17:20 hours by
START MG. Lining of the collection trench

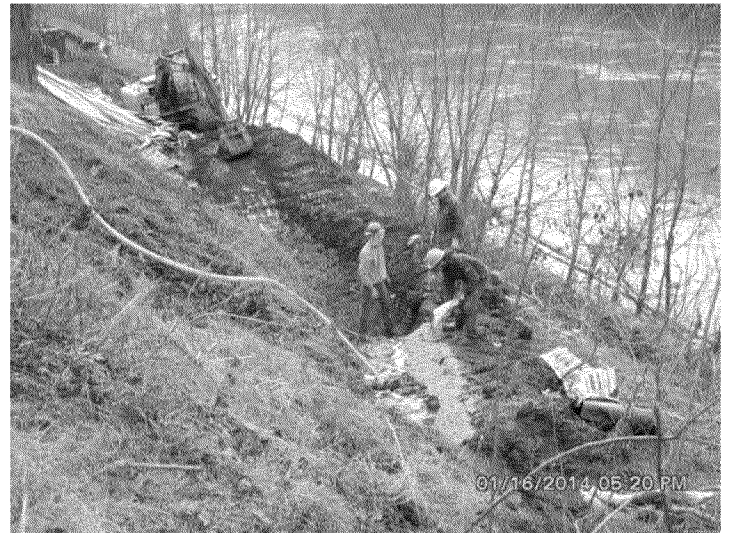
Photo No. SAM_1823; Taken on 01/16/14 at 17:20 hours by
START MG. Lining of the collection trench

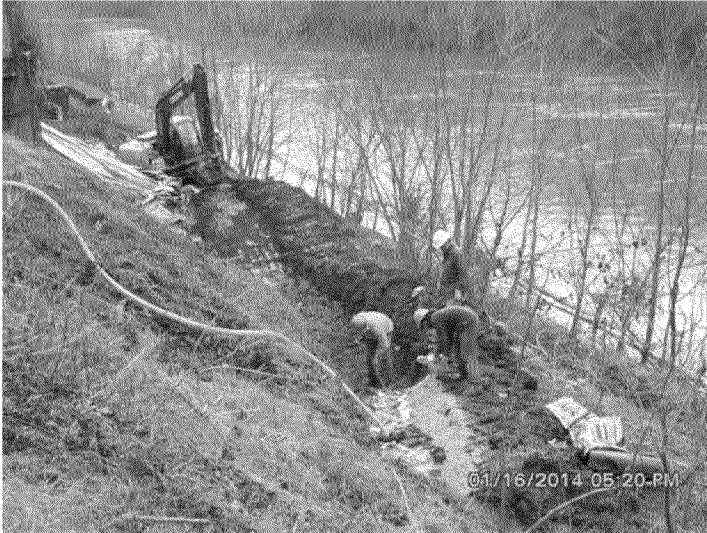
Photo No. SAM_1824; Taken on 01/16/14 at 17:21 hours by
START MG. Lining of the collection trench

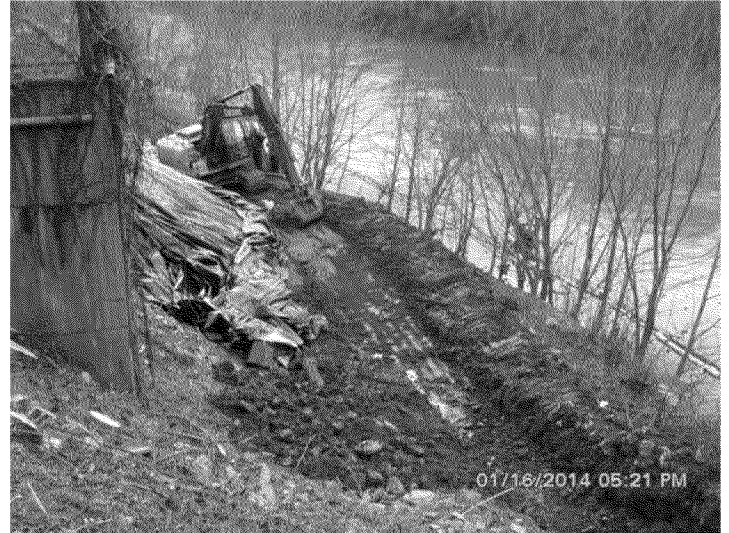
Photo No. SAM_1825; Taken on 01/16/14 at 17:21 hours by
START MG. Expansion of the collection trench

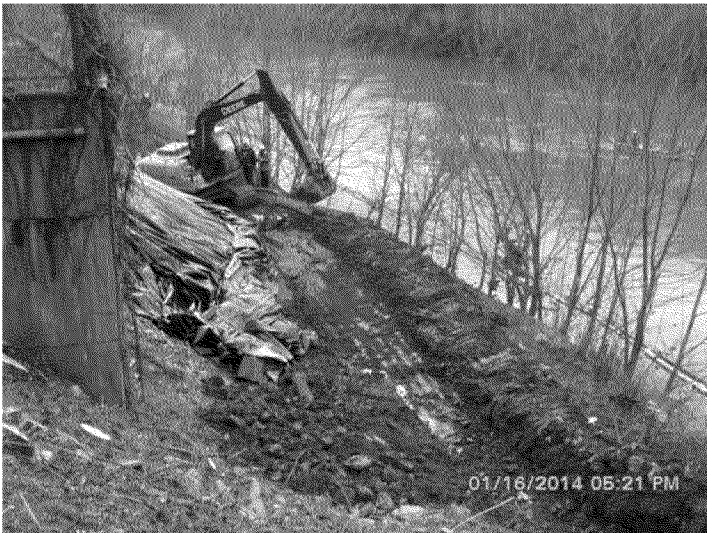
Photo No. SAM_1826; Taken on 01/16/14 at 9:33 hours by
START MG. Expansion of the collection trench

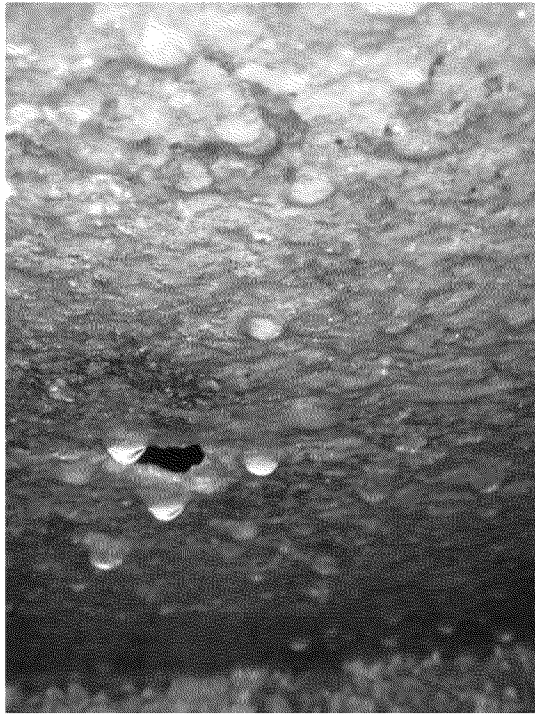
Photo No. IMG_1157; Taken on 01/17/14 at 9:35 hours by
START GN. A view of the hole in the bottom of the tank, from
under the tank.

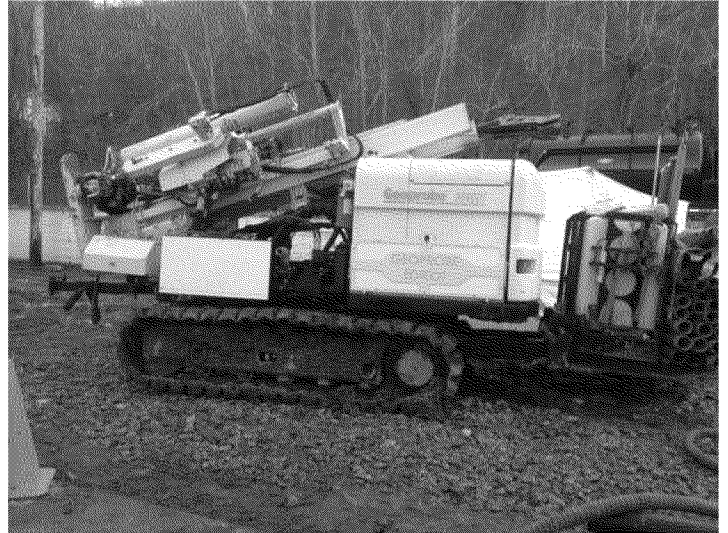
Photo No. IMG_1158; Taken on 01/17/14 at 9:41 hours by
START GN. GeprobeTM unit owned by Enviroprobe.

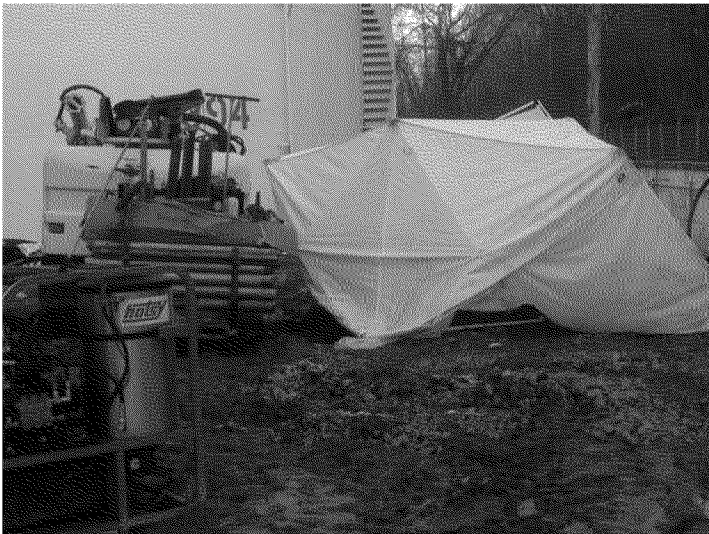
Photo No. IMG_1159; Taken on 01/17/14 at 10:42 hours by
START GN. GeprobeTM unit with demolished tent.

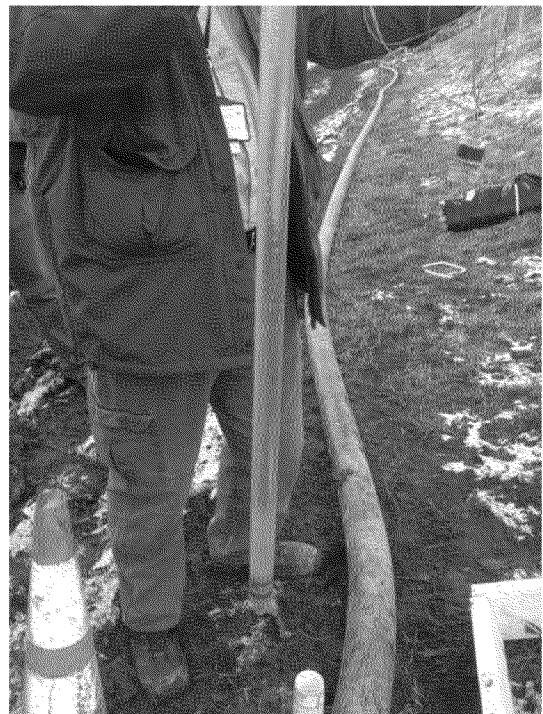
Photo No. IMG_1160; Taken on 01/17/14 at 10:46 hours by
START GN. Bailer of groundwater retrieved from monitoring
well MW-4.

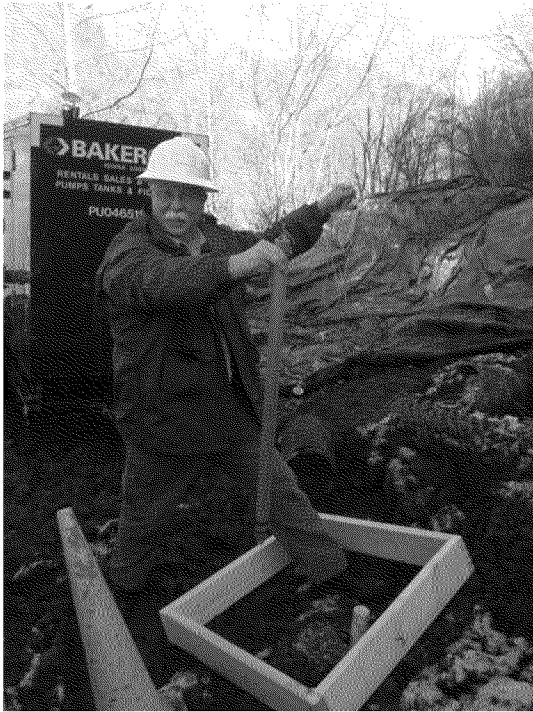
Photo No. IMG_1161; Taken on 01/17/14 at 10:49 hours by START GN. Bailer of groundwater retrieved from monitoring well MW-3.

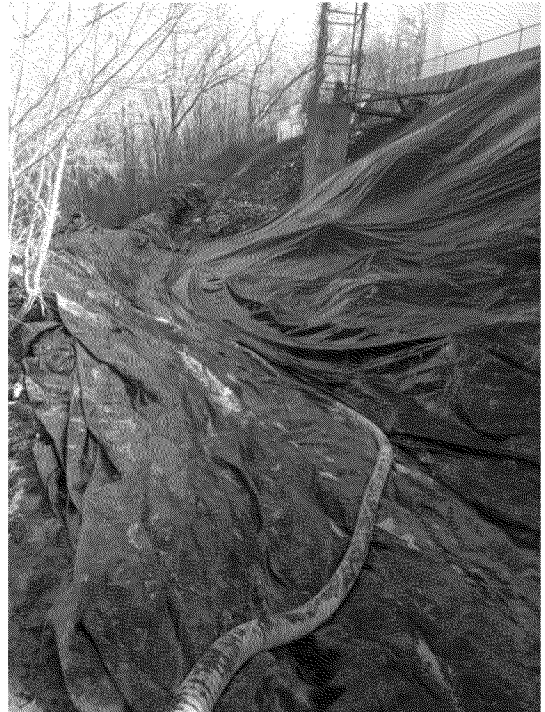
Photo No. IMG_1162; Taken on 01/17/14 at 10:49 hours by START GN. Poly-lined water collection trench/sump.
